Inadequate Grounding System Allows Costly Lightning Damage at Municipal Safety Center

The Jackson Township, Ohio safety center was completed in 2004. Because its electrical grounding system was incorrectly designed and improperly installed, lightning strikes to the antenna tower (visible in the background) frequently left fire and police services without emergency dispatch capability.

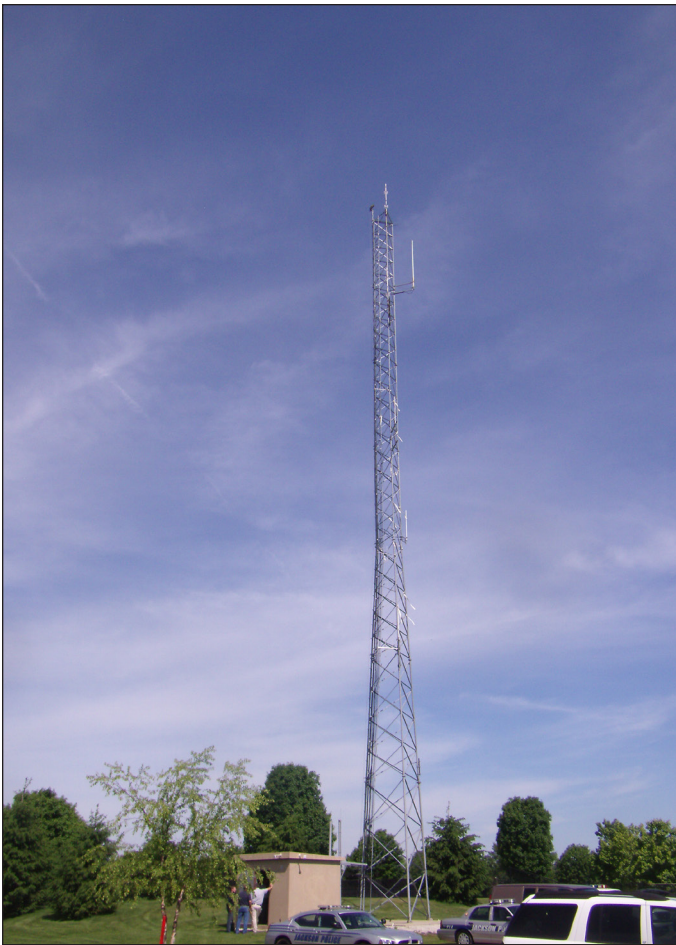
Figure 1. Jackson Township's fire and police communications equipment is housed in the small remote communications building to the left of the 140-ft antenna tower. The tower has attracted many lightning strikes, and because it was poorly grounded, lightning energy was able to damage equipment in the building and elsewhere on the municipal campus.

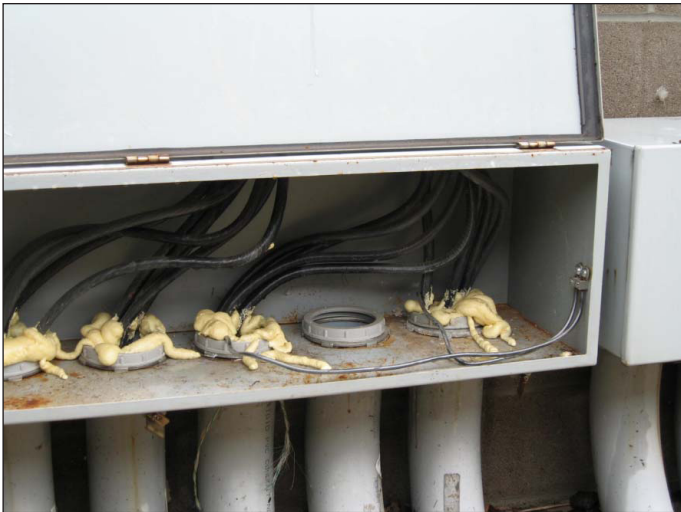
- Two parallel grounding conductors were found connected between one painted utility meter cabinet and the main wireway in the safety building (**Figure 2**). Aside from the incorrect and non-compliant connection, the 100-ft-long conductors could function as antennae for induced currents or stray RF and thereby inject electrical noise into the grounding system.

Figure 2. A pair of grounding conductors (front right) improperly connected to a utility meter cabinet. The cables ran 100 ft to the main wireway inside the safety center, and their length invited stray current pick-up by the grounding system.

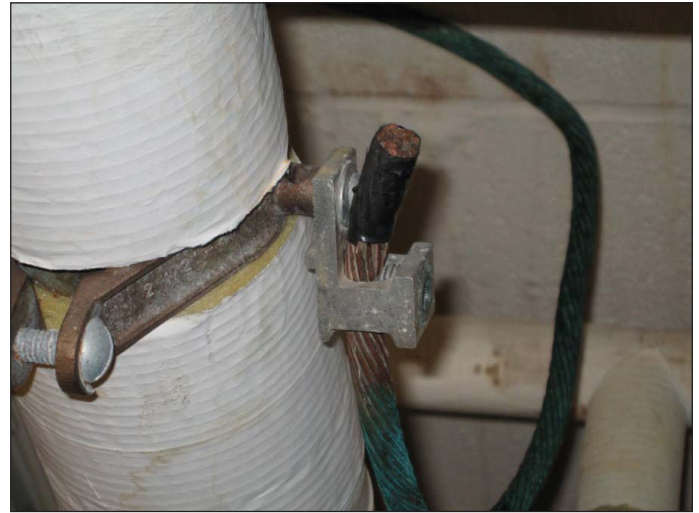
- Water line connections weren't jumpered across flanges, and the termination point of the grounding conductor at the water line was made between two flanges on the street side of the line using an improvised connection (**Figure 3**).

Figure 3. An improper grounding connection between two flanges on the street side of the water line. Flanges were also missing jumpers to provide a path to earth.

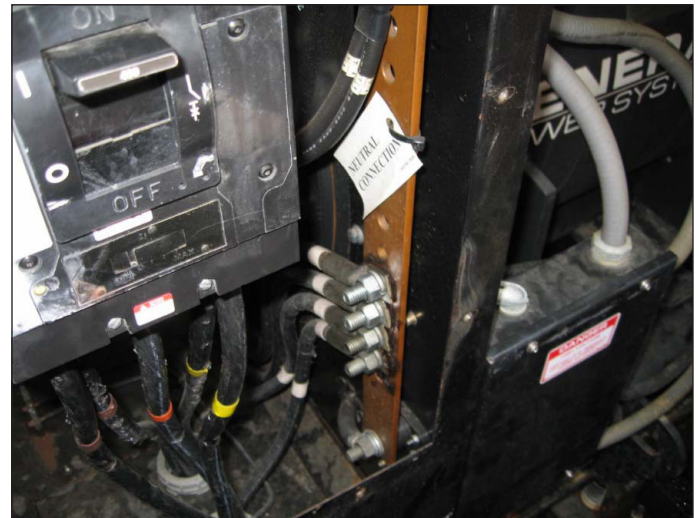
- Current on the grounding conductor at the service entrance measured 7.6 A. Among the several likely sources was a non-compliant ground-neutral bond at the emergency generator (**Figure 4**). The transfer switches for the generator

Figure 4. The neutral-ground connection (bottom center) at the emergency generator constitutes a short condition because the transfer switch is three-pole, meaning that the generator is not a separately derived source. The improper connection can inject current into the grounding system.

are three-pole, therefore the generator is not a separately derived source and doesn't require a neutral-ground connection. With the existing bond, any current on the neutral conductor would enter the grounding system, where it could affect sensitive equipment.

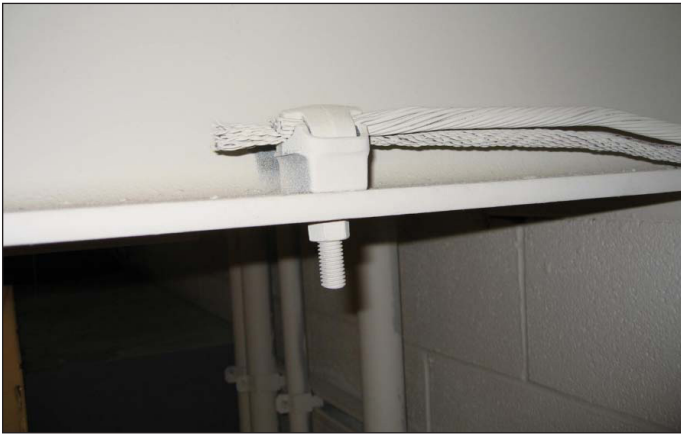
- The building steel grounding connection consisted of a non-compliant bar-tap bolted to a painted steel beam (**Figure 5**). That's an obvious high-resistance connection. Two such connections were found *inside* the fire station garage, yet neither column was connected to earth. Down-conductors should preferably be grounded to driven electrodes *outside* the building. Since the columns weren't earthed, lightning energy followed the grounding conductor back into the electrical system and the equipment on it.

Figure 5. A building steel grounding conductor and a braided lightning rod (air terminal) down-conductor are shown connected to a painted steel member by an unapproved bar-tap. Building steel connection to earth was unknown and the connection has high resistance. The air terminals should have been earthed to the grounding electrode system or ring ground outside the building.

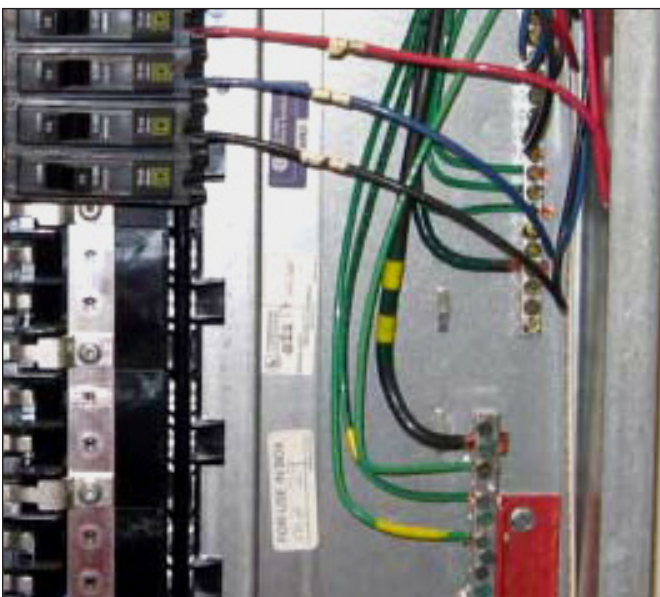
- Cookson also found an isolated ground (IG) short at an uninterruptible power supply (UPS) by-pass switch. The IG had been run from a panel that serves communications, phone and network equipment, where it terminated at a ground bar that also contained electrical and equipment grounds (**Figure 6**). Mixing IGs with other grounds defeats the purpose of the IGs, which by the Code, must terminate only at the main disconnect ground-neutral bond. Computers, electronic equipment and networks served by an improperly connected IG may see electrical noise, elevated ground potentials and stray currents and may therefore not function correctly.

Figure 6. A panel serving communications, phone and network equipment contains two grounding bars (at right). The lower one contains both isolated ground wires (IG, yellow-green) and electrical equipment ground (green) conductors. This non-compliant condition negates the IG, which was also incorrectly bonded to the UPS by-pass switch downstream.

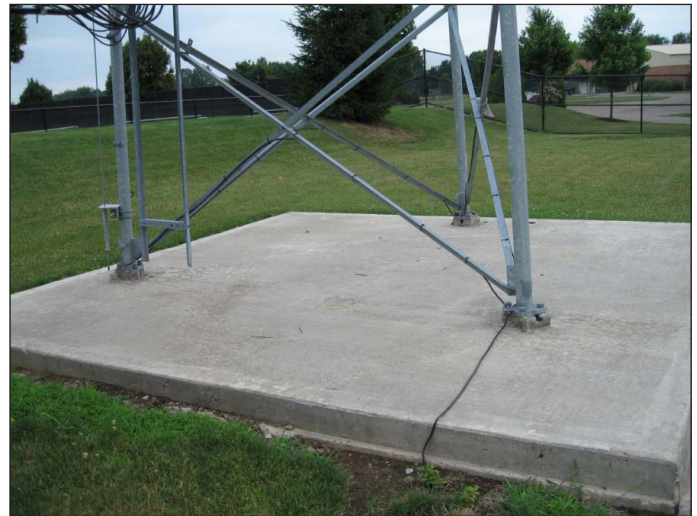
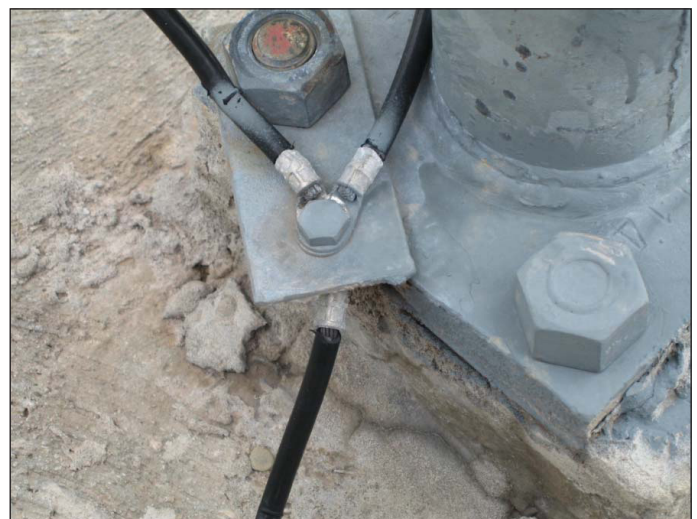
The sloppy installations described above probably decreased the facility's overall power quality, but most of them likely didn't contribute to lightning damage. That damage was caused in large part by the more serious mistakes Cookson found at the tower/transmitter. There, he discovered three separate connections to earth: one from a single tower leg (and it was poorly made at that, with ground resistance of 60 ohms) (**Figure 7**); another one, at 35.4 ohms, from the outdoor grounding bus

Figure 7. One of three existing earth connections at the antenna tower was made to a tower leg (upper photo). It terminated at an 8-ft grounding electrode. The mechanical connection to the tower (lower photo), was made to a galvanized and painted steel tab, which was itself bolted to the galvanized steel tower support flange. This connection method imparts high resistance and is not recommended.

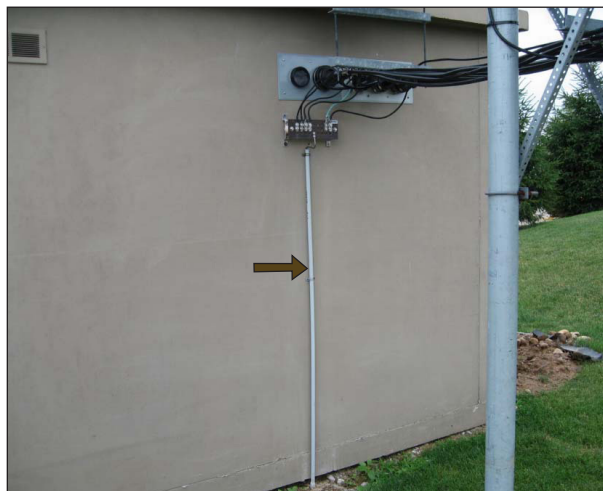
(Figure 8) and a third one measuring 42.5 ohms from a sub-panel feeding the transmitter building (Figure 9). Conductors from the latter two sources were joined, thereby setting up a ground loop.

Figure 8. A separate earth connection at the tower/transmitter site was made from the outdoor grounding bar seen just beneath the wall penetration. The grounding conductor (in conduit, arrow) connects with the tower ground at the opposite side of the building, forming a three-way ground loop.
