Proper Grounding and Bonding Saves Thousands of Dollars at Ohio Safety Complex

The Medina, Ohio's Public Safety Complex is housed in the city hall. Improper electrical grounding and bonding caused expensive equipment failures and took the city's vital emergency communications system offline.

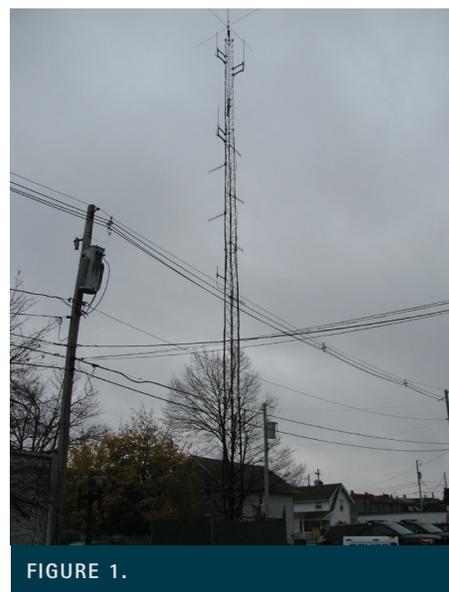
FIGURE 1.

The Medina safety complex's antenna tower often attracted lightning, most notably during a large storm in 2013. Unfortunately, the tower was inadequately grounded, a serious discrepancy that enabled lightning energy to enter the safety complex, where it destroyed communications and other sensitive electronic equipment.

"Our building inspectors also examined our circuits and after that we thought we were getting into pretty good shape," Piccoli said. "Then disaster struck. We suffered a catastrophic loss one night in 2013 during a bad storm. Lightning struck our tower (Figure 1). We lost two-thirds of our dispatch center. Our emergency service workers had to communicate — if they could communicate at all — by using their laptops and portable radios. It didn't take a rocket scientist to see that an electrical surge had entered our system. Ironically, the department had just completed an upgrade to its grounding system, but the company who installed it maintained that a surge wasn't our problem."

The complex experienced over \$20,000 worth of damages from the lightning strike. It took out Ethernet cards in one server, and then cascaded to other cards in four or five other computers and three radio consoles.

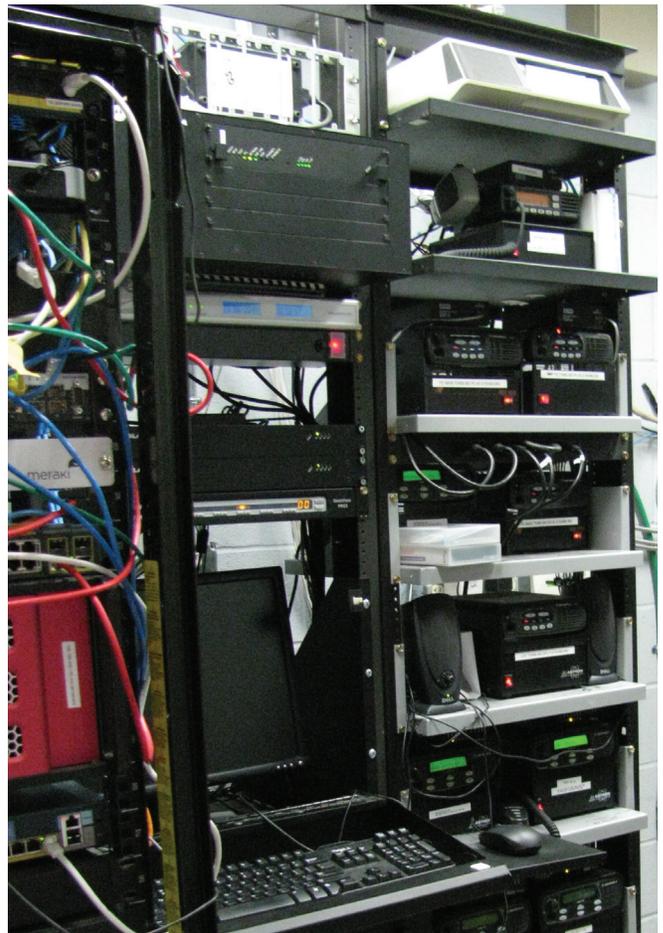
FIGURE 2.

Zaremba explained how he believes the damage probably progressed. "Our IT and radio equipment components are mounted on separate racks (Figure 2). The grounding in our server rooms was, at the time, mostly on our radio racks, which were installed by one vendor. Unfortunately, my (IT-based) dispatch racks were tied to that radio rack since we shared an Ethernet cable to a time-synching computer on the radio rack. So, in effect, the radio racks were grounded to our computers on our IT rack, which, it turns out, was installed by a different vendor.

Equipment on adjacent IT server racks (at left) and radio racks (at right) suffered major damage from the 2013 lightning strike. It is believed that the racks shared a CAT-5 Ethernet cable to a time-synching computer. When lightning energy entered the building due to grossly inadequate (and incorrect) grounding and lightning protection, the shared CAT-5 cable provided a path for that energy to damage both the IT and communications systems.

It is important to note that racking on the IT server side was appropriately grounded. The fatal deficiency was that grounding on the radio side was improperly installed by a different vendor.

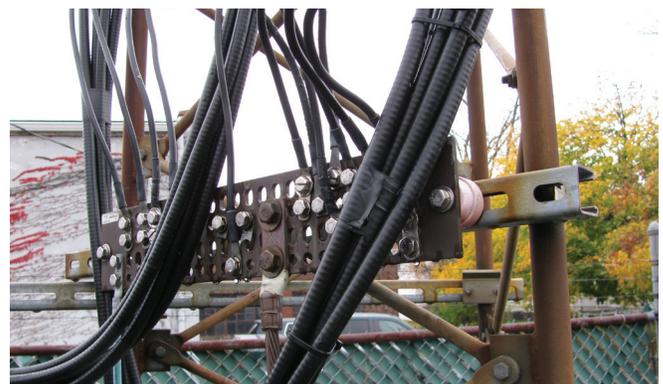
FIGURE 3.

A copper grounding busbar on the tower (center of photo) connects grounded shields on waveguides and coax cable shields serving various antennas (smaller-diameter cables). The large-diameter, vertical green grounding cable visible at the far lower left corner connects the busbar with the three driven electrodes and the buried copper ring ground surrounding the tower.

"We shared that time-synching computer on the radio rack via a standard CAT-5 Ethernet cable. We suspect that the cable was draped across one of the antenna wires coming into the building from a copper grounding bar attached several yards up the tower (**Figure 3**). The surge probably jumped to the CAT-5 cable and then took out five Ethernet ports on the IT side, four of which were on detective computers. The radio rack and its equipment also took the hit, of course."

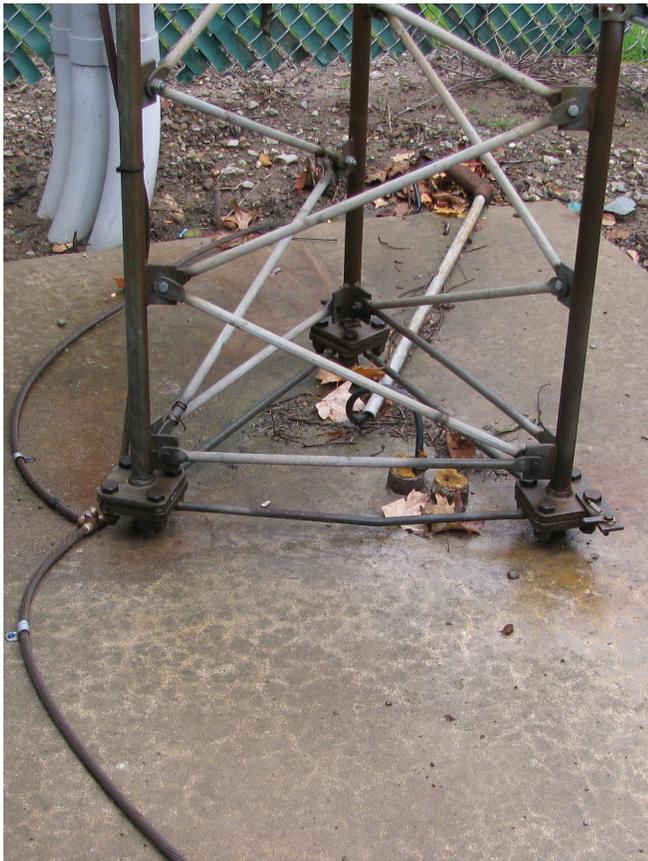
FIGURE 4.

The base of the antenna tower is shown here after the upgrade. The tower had originally been fitted with two grounding rods, but the rods had corroded unevenly, giving rise to a difference in their ground impedances. During the 2013 strike, lightning energy would have favored the lower-impedance rod, setting up a massive ground loop current in a circuit that included the interior grounding bar and the improperly grounded equipment racks shown in Figure 2.

Cookson first inspected the grounding system at the base of the center's three-legged lattice tower, **Figure 4**, and found several serious issues. The tower had originally been provided with two electrically separate grounding rods, which was in itself a deficiency. To make matters worse, the rods were made from a material that corroded unevenly, a condition that led to the rods having different ground impedances. Thus, when lightning struck the tower, its energy would naturally have favored the lower-impedance rod of the two. In the process of seeking earth, the incoming energy would have set up a massive ground

loop current that included both rods and an interior grounding bar (**Figure 5**) located behind the cabinets in the building's communications room. Since – as Zaremba discovered earlier – the interior bar was also improperly connected directly to the equipment racks and to the main grounding bar (MGB), **Figure 6**, it was quite possible that lightning energy could flow from the tower to the interior bar and from there to the racks and downstream equipment.

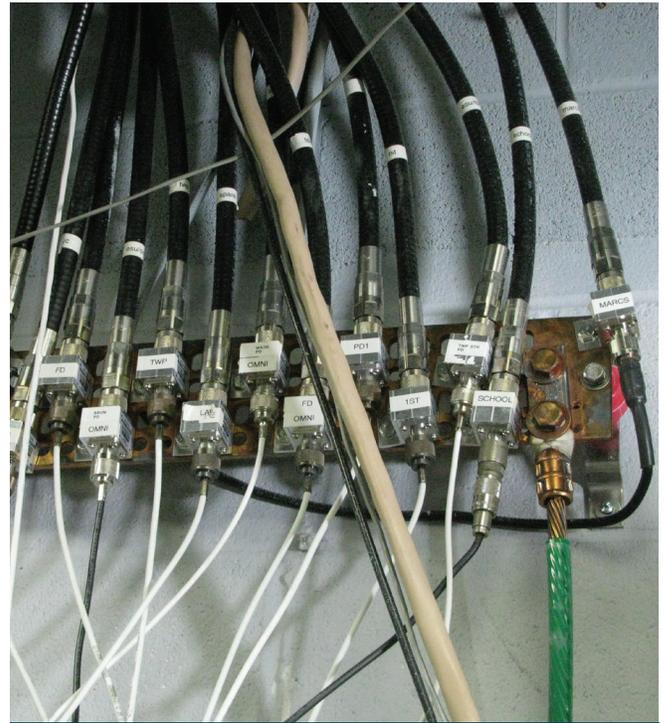
FIGURE 5.

A copper grounding bar located in the server room near the communications cabinets. The bar collects grounding cables from the tower and the police department side of the safety complex. The AWG 4/0 green wire at lower right in the figure connects to the main grounding bar shown in Figure 6.

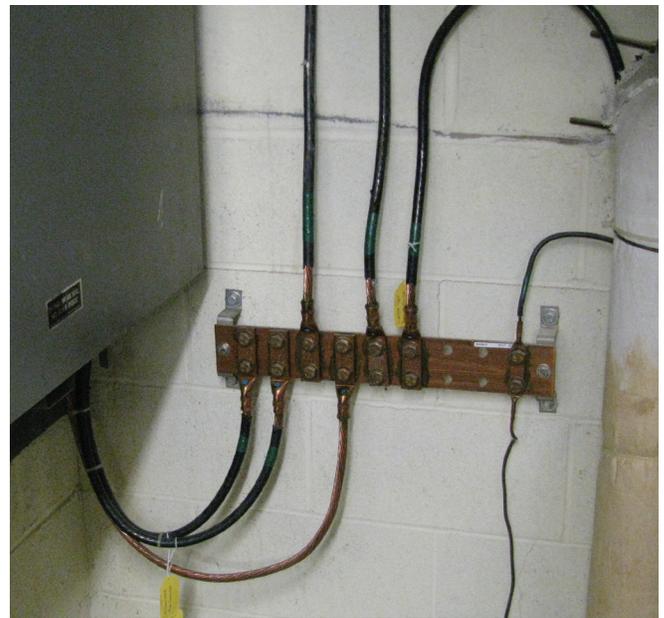
FIGURE 6.

The complex's main grounding (MGB) bar collects feeds from subsidiary bars located throughout the facility. The green cable at the top of the bar originates at the bar shown in Figure 5. The complex' electrical service entrance at the left of the MGB and the water service entrance is at the right.

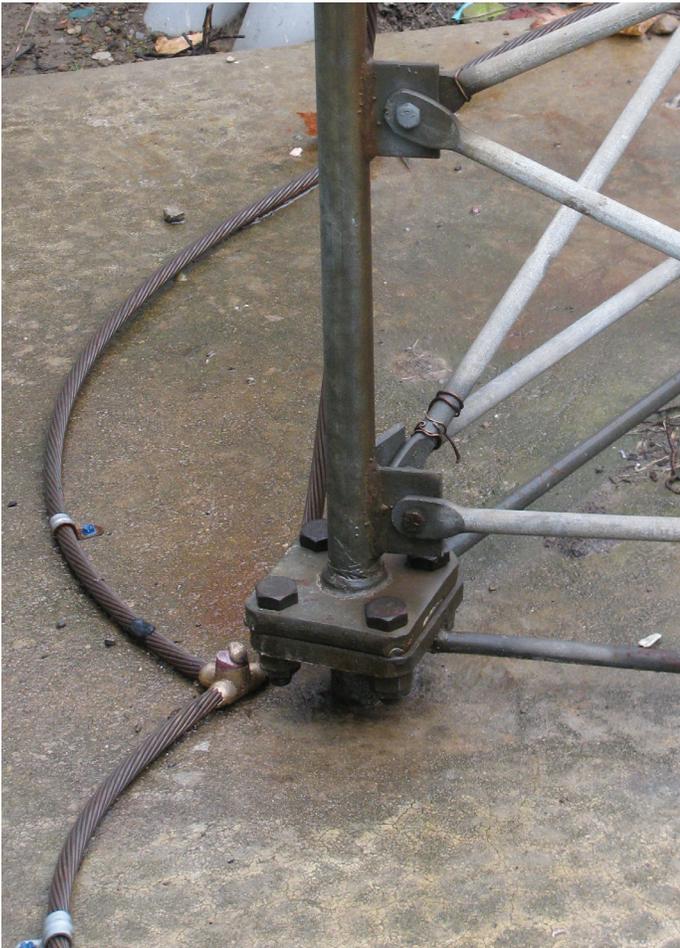
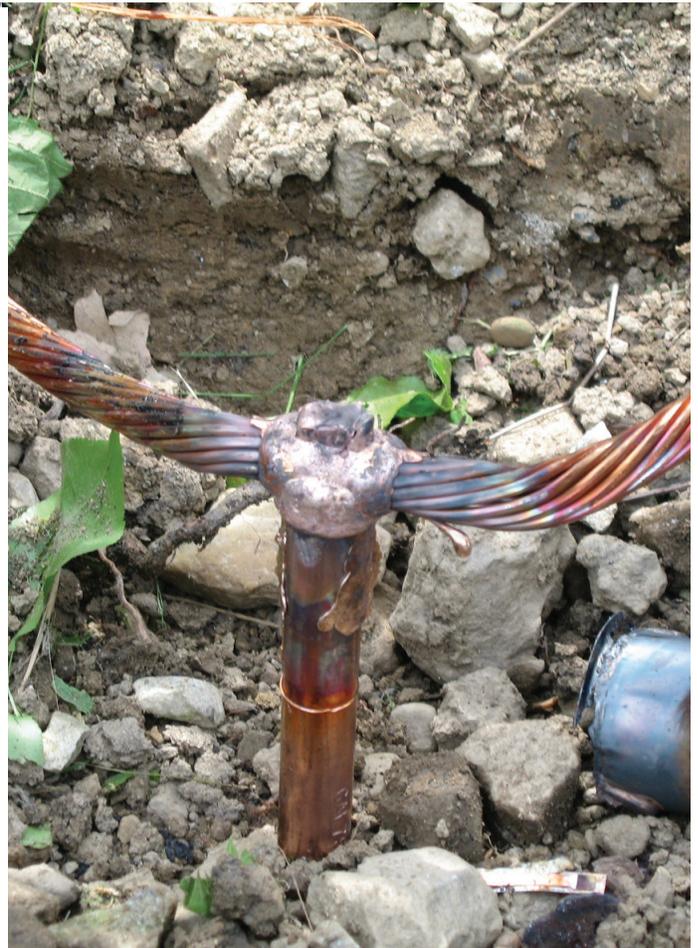
New grounding connections at the tower base: 7a (left): exothermic welds bond grounding cables to one of the tower's legs; 7b (right) exothermic welds also bond grounding cables with an extension of the buried copper ring ground.

Cookson first replaced the existing rods with three copper-clad 10-foot x 3/4-inch rods, all of which were bonded to the legs of the tower and to a new bare copper 4/0 copper ring ground that was installed around the tower (Figure 7a and 7b). The existing rods (and therefore the tower) had been connected to the interior collector bar shown in Figure 5, and a lead from that bar was (mistakenly) directed to the racks shown in Figure 2.

The most important result of Cookson's corrections and subsequent improvements to the complex's grounding system was that energy from any future lightning strike to the tower would be directed directly to earth via the low resistance/impedance ring ground and electrodes at the tower base and
