**The Application of
Copper-Nickel Alloys
in Marine Systems**

**International Copper Association, Ltd.
Copper Development Association Inc.
Nickel Development Institute**

MARINE APPLICATIONS OF COPPER-NICKEL ALLOYS

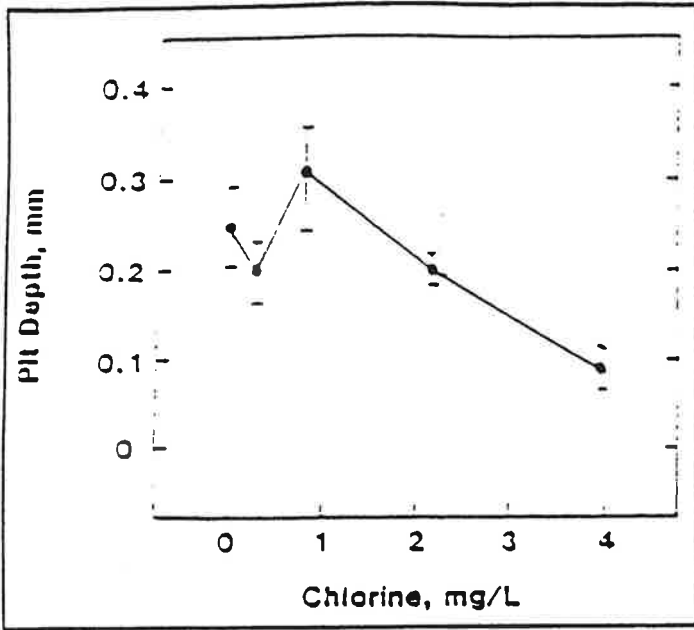
Figure 12 Depth of impingement attack versus chlorine level for 70-30 copper-nickel with an impingement jet velocity of 9 m/s.

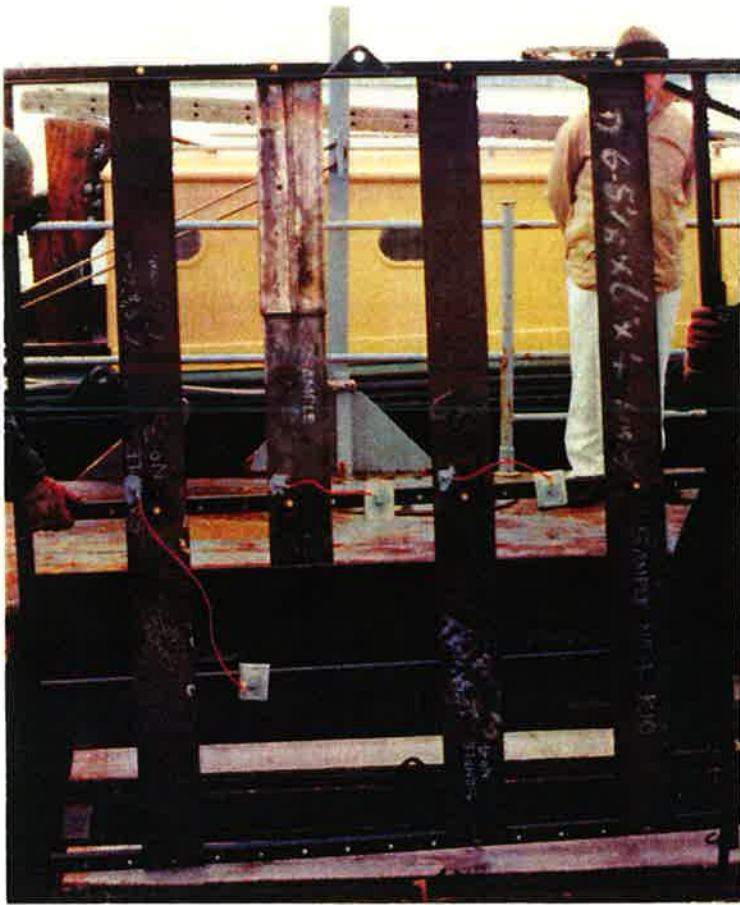
Figure 15.
Raft Site.
Mounted panels being
lowered into place.

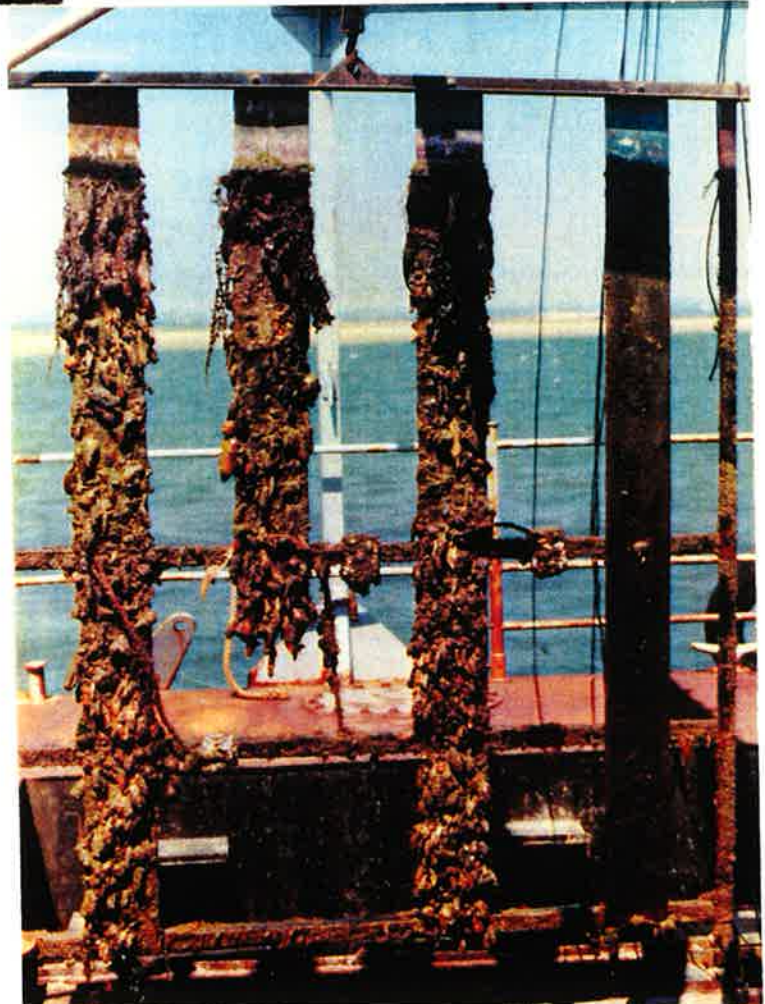
Figure 16.
Raft site.
55 weeks immersion.

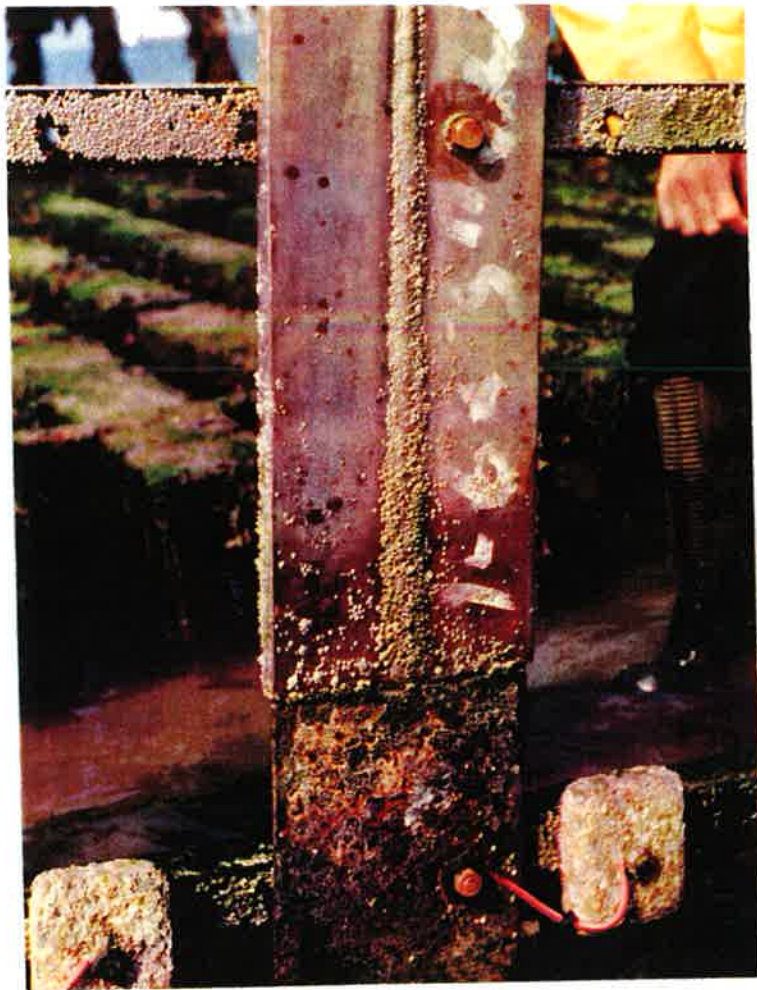
Figure 17.
90-10 copper nickel
and 50D steel after
16 weeks on the half
tide site.

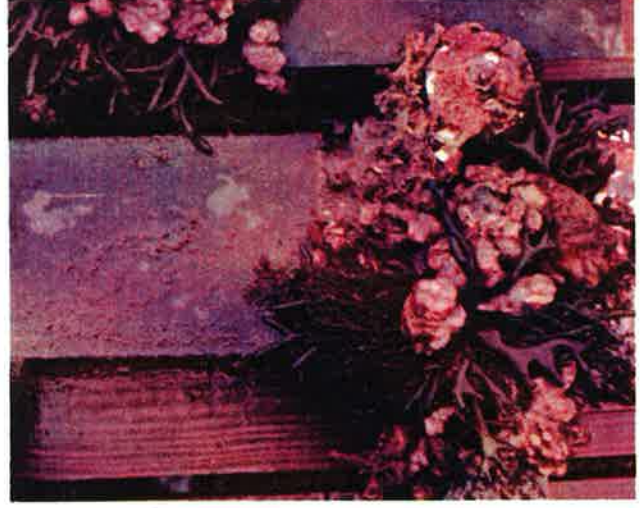
Figure 20

The influence of 90-10 Cu-Ni on the fouling of an adjacent non-toxic (vinyl paint) surface in sea water during the summer fouling season. Exposure times are (from left to right): Top—1 week, 3 weeks, 7 weeks. Bottom—10 weeks, 24 weeks.

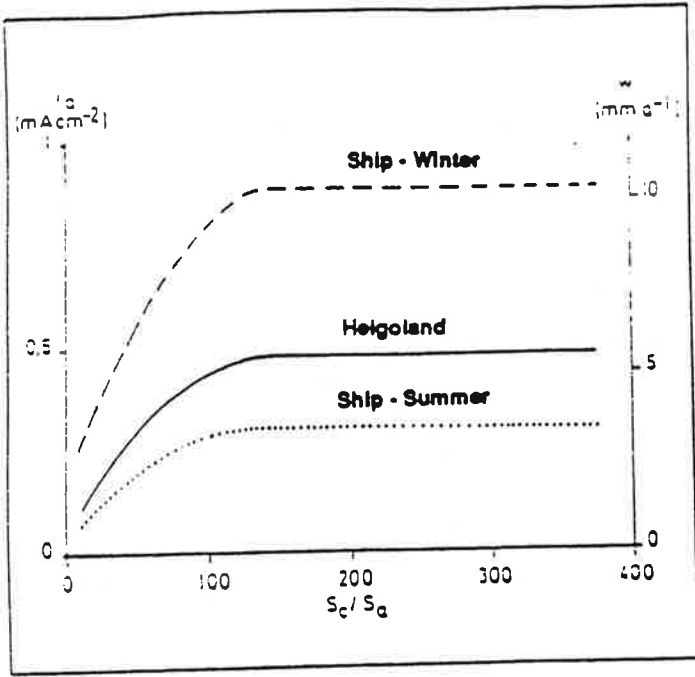
Figure 8 Anodic Current Densities vs. Cathode-to-Anode Surface Area Ratios for Clad Copper-Nickel/Steel Specimens with Machined Defects to Expose the Steel.

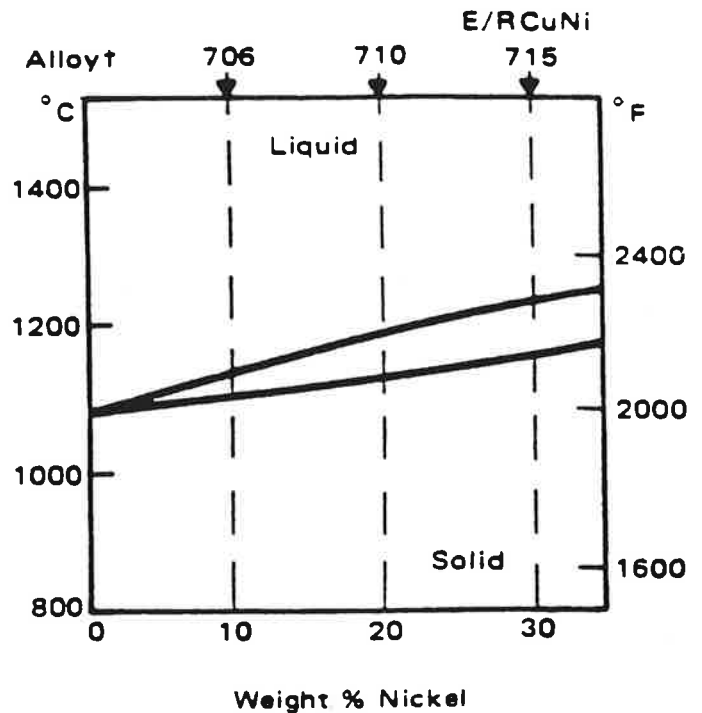
Figure 1 Copper-Nickel Phase Diagram
