# All-Copper Grounding Systems End Million Dollar Losses at Emergency Response System

Lightning Damage Averted, Public Safety Assured

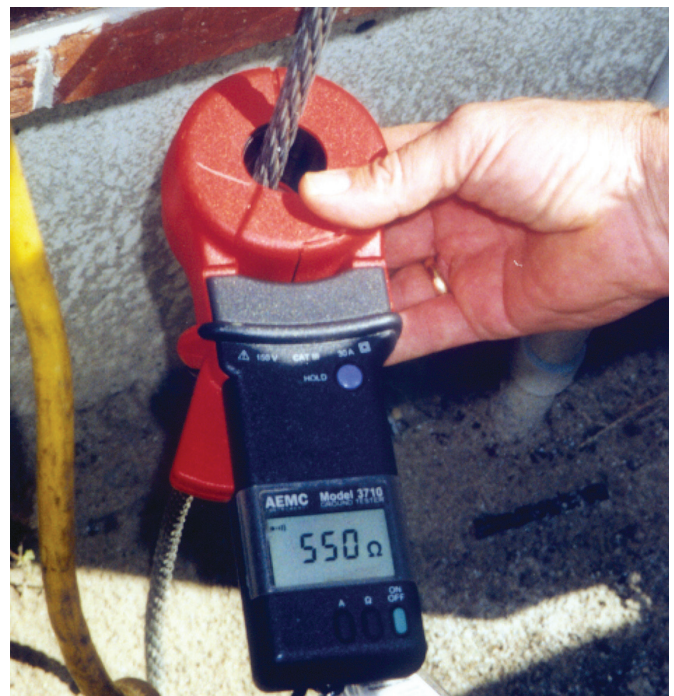
FIGURE 1.

The Apopka antenna tower was originally grounded to a length of steel all-thread rod and a counterpoise (a length of buried bare AWG 4/0 copper cable). Ground resistance was 550 ohms, far too high to provide useful grounding and excessive even for lightning protection. Lightning surges had often bypassed the electrode, destroying equipment inside the transmitter building.

West found that the grounding "electrode" serving the tower and transmitter room was actually a length of ordinary steel all-thread rod driven into the ground near the tower base. Resistance to earth was an astonishing 550 ohms (Figure 1), 22 times the maximum resistance cited by the National Electrical Code® and more than two orders of magnitude higher than the level recommended by such standards-setting organizations as IEEE and TIA/EIA. The makeshift electrode was supplemented by a length of buried cable (counterpoise) which, in turn, was connected to one of four copper strips leading to copper firewalls. West discovered that the contractor had simply buried three of the copper strips in the ground, never connecting them to the electrodes.

Donnelly and West installed a new 60-ft (18-m) copperclad electrode close to the tower (Figure 2) on the premise that a lightning strike would tend to travel vertically. A deep electrode was used because of the soil's high resistivity. The new electrode's resistance is an acceptable 4.3 ohms.

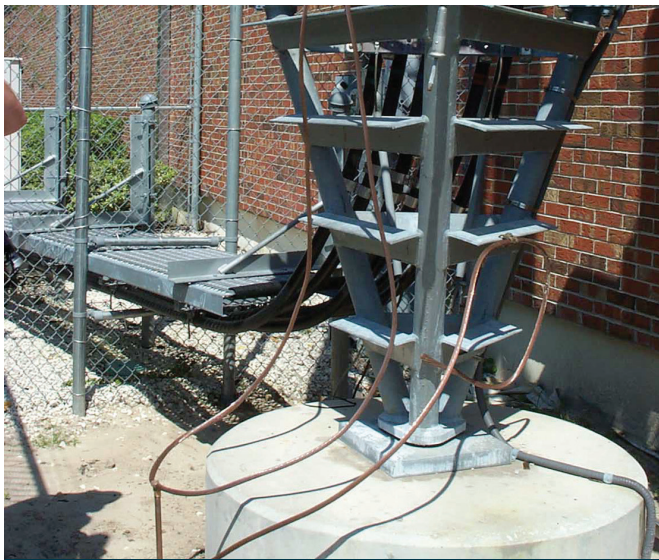
FIGURE 2.

Bare AWG 4/0 copper conductors are exothermically bonded to a new 60-ft (18-m) grounding electrode at the Apopka tower base (lower left) replacing the all-thread rod. Resistance to earth is 4.3 ohms.

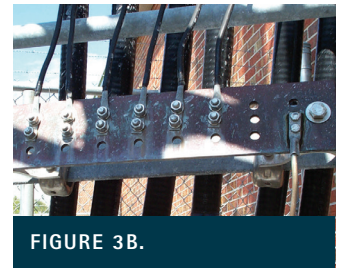
FIGURE 3B.

Weatherproofed leads from antenna cable shields (Figure 3a.) are bonded to the large bar (Figure 3b.); and a lead from there connects to a second copper bar (Figure 3a, lower right), which was added for ease of access. An exothermic bond connects the bar to the grounding electrode.

Donnelly and West next ran AWG 4/0 leads from the new electrode to a copper bus on the tower (Figure 3a), which was then connected to a second bus (Figure 3b) which served as a junction point for the coaxial cable shields, and to the firewalls and copper strips shown in Figure 4. The copper strips were left in place but were supplemented with additional lengths of AWG 4/0, and all four strips were bonded to the counterpoise.

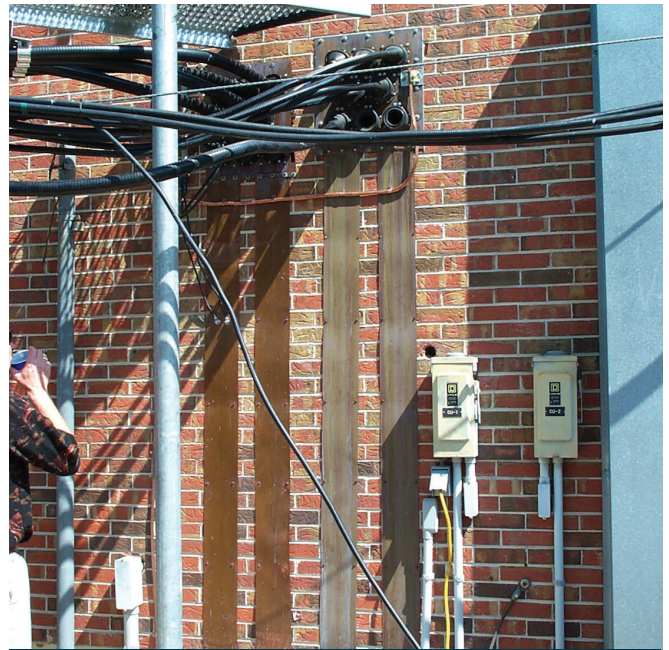
FIGURE 4.

Only one of the four copper strips shown leading from the site's two antenna cable firewalls was actually connected to the counterpoise. The other three were simply buried. The copper strips are now augmented with AWG 4/0 copper securely bonded to the firewalls and to the new grounding electrode.

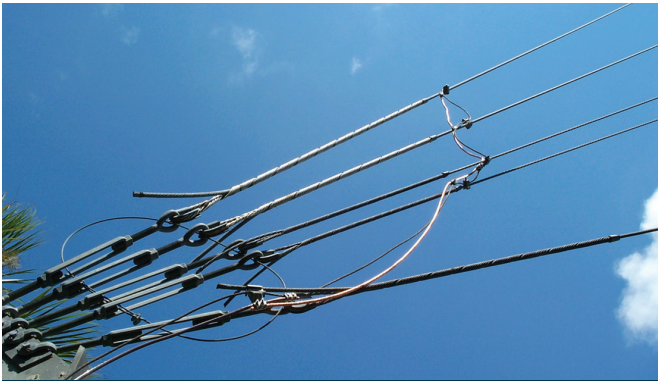
FIGURE 5.

New, AWG 2/0 grounding conductors were piggybacked over existing AWG 2 conductors at the tower's three sets of guy wires (Figure 5). The heavier conductors were run to three new 60-ft (18-m) grounding electrodes. Chemical-type electrodes had been installed 10 years earlier, but because they had never been serviced, resistances had risen to between 35 and 64 ohms.<sup>1</sup>

One of three sets of five guy wires, each supporting the Apopka tower. New AWG 2/0 ground leads from the wires connect to a new low resistance electrode. Resistance at the new electrodes ranges from 5.3 to 6.7 ohms.

Resistance of the new deep electrodes ranges between 5.3 and 6.7 ohms. A clear indication of their effectiveness can be seen in the 150-160 mA of RF current they draw off the guy wires.

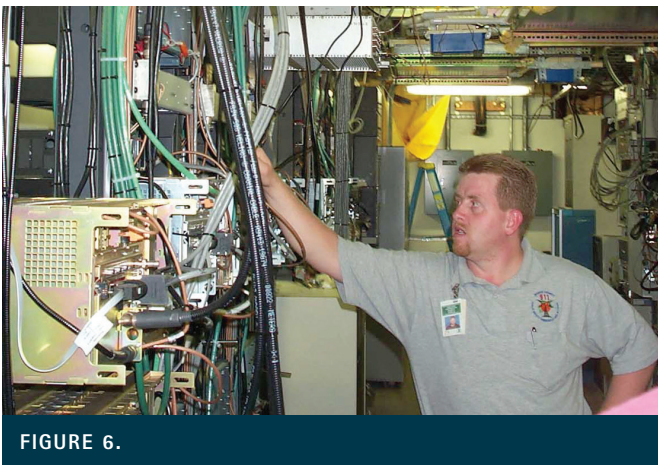
FIGURE 6.

The equipment room houses more than \$2 million worth of transmitters, switches and auxiliary equipment (Figure 6). West found the two rows of equipment racks bonded to the firewalls by way of a halo ground, and from there, to the main grounding electrode and counterpoise outdoors (Figure 7a and 7b).

Orange County technician Dave Hazen checks transmitter equipment at the Apopka site. The room, one of eight like it in the county system, contains more than \$2 million worth of communications gear. Equipment racks were originally grounded by way of a halo ground circling the walls, but equipment chassis themselves were never bonded to the racks.

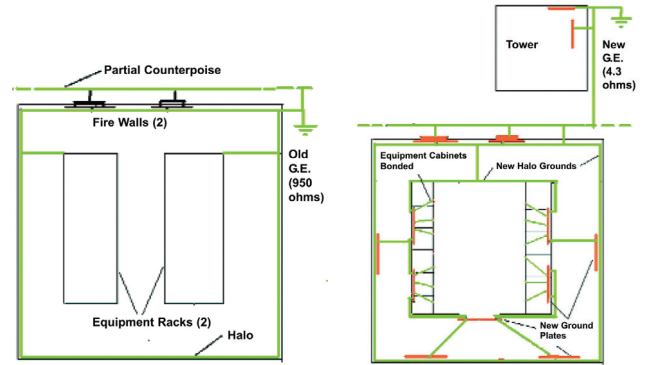
Schematic diagram of the Apopka site grounding system: as originally installed (Figure 7a), and as upgraded (Figure 7b). Green lines identify grounding conductors; copper color indicates new grounding plates. Improvements include bonding to equipment cabinets and racks, an additional halo ground, copper grounding plates, a lowresistance grounding electrode and exothermically welded bonds.

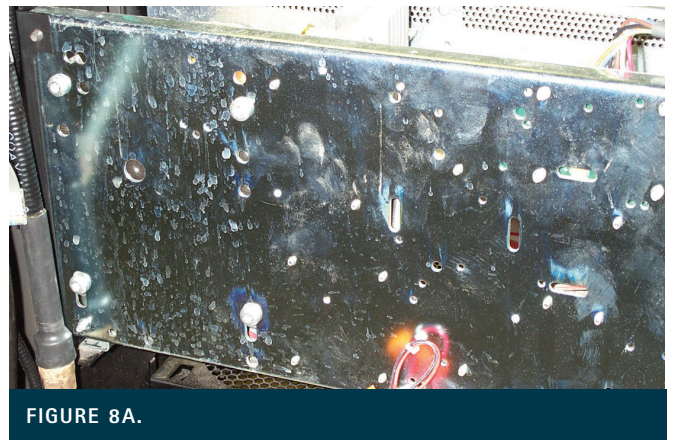
FIGURE 8A.

The equipment chassis (cabinets) themselves hadn't been bonded to the racks. During a thunderstorm in mid- 2002, a leak in the building's roof left a trail of water down one of the racks and onto the concrete floor. A lightning strike followed the moisture trail (wet concrete is a pretty good conductor), destroying expensive transmitters and leaving the 911 system short by two communications channels (Figure 8a and 8b).

Figure 8a. Water stains on an equipment cabinet left by a leaking roof. The moisture trail, which continued to the concrete floor, allowed a lightning strike to destroy expensive transmitters and took two communications channels off the air. Figure 8b. Dave Hazen holds circuit boards destroyed by the lightning strike. The damaged equipment put public safety at risk and cost \$13,000 to replace. Lightning caused almost \$2 million in similar damage to the entire system over 11 years. An all-copper grounding system installed in 2002 put an end to the damage, improving public safety and eliminating high repair costs.

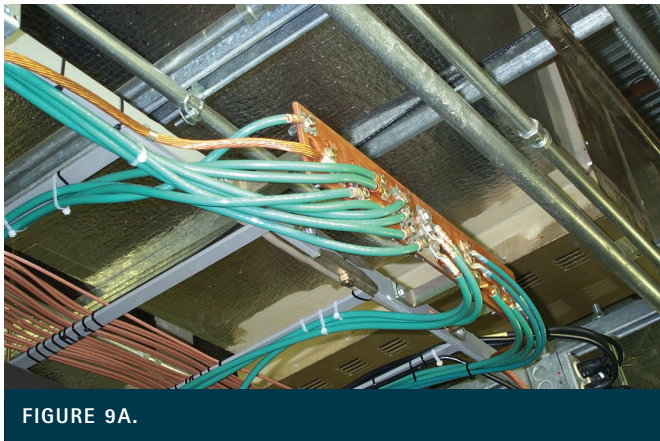
FIGURE 9A.

Figure 9a. A copper plate connects several equipment chassis grounding conductors with an AWG 2/0 halo ground. Figure 9b. Insulated mats installed under equipment racks at Apopka help prevent lightning from seeking out a watersoaked concrete floor, as it did after the site experienced a leaking roof.

- First, all equipment chassis were firmly grounded with AWG 2 copper. The heavy leads are bonded to a series of copper ground plates mounted at the top of the overhead rack supports. The plates are connected to each other in a halo ring made from bare AWG 2/0. Equipment racks are also bonded to the plates (Figure 9a).
- A second AWG 2/0 halo was mounted on the comm room walls and connected to the inner ring, again using copper plates. Bolted connections on the plates ensure sound bonding. More AWG 2/0 connects both halos to the copper firewalls.
- Rubber mats were placed under equipment racks to help preclude a conductive path (Figure 9b).

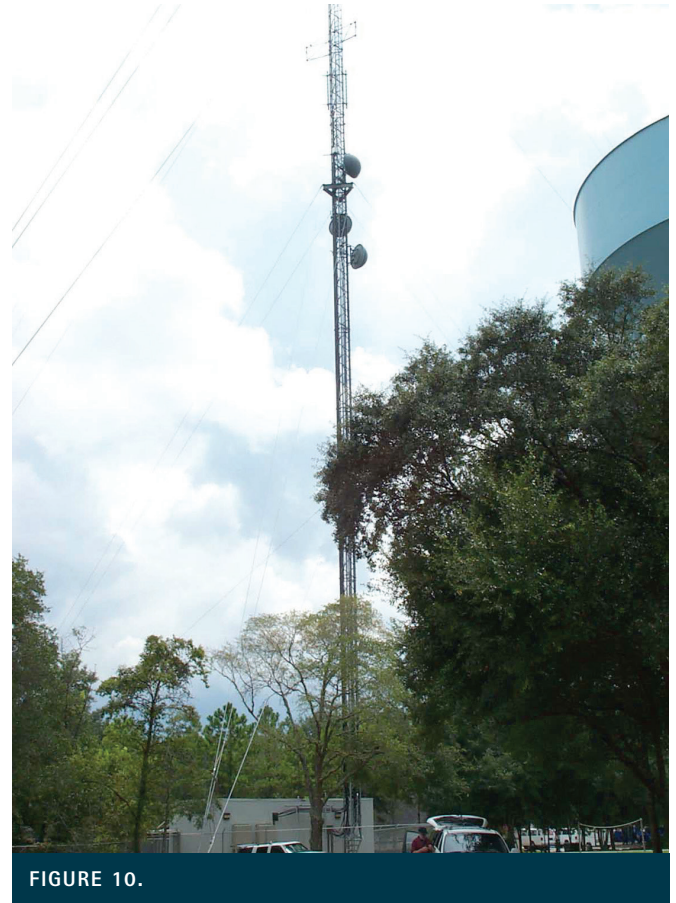
FIGURE 10.

The Clarcona transmitter site (Figure 10) is smaller than the Apopka hub, but Donnelly and West found it to be plagued with similar problems. Like Apopka, the site had taken severe lightning damage due to high resistance electrodes, a lack of proper bonding (Figure 11), and inappropriate grounding at equipment cabinets.

Like the Apopka hub, Orange County's smaller Clarcona site suffered from high ground resistance, inadequately maintained chemical electrodes, poor bonding and ungrounded equipment cabinets. Upgrades include a new 60-ft (18-m) deep electrode with less than 5 ohms resistance, firm bonding of all connections, installation of heavy copper grounding conductors to all equipment cabinets plus new halo grounds in the comm room.

The grounding team's first order of business was to replace high-resistance grounding electrodes at the tower and guy wires with five 60-ft (18-m) copper-clad rods. The new electrodes register only 3.4 ohms resistance. AWG 2/0 conductors were bonded to the tower and to the station's two firewalls. An obviously corroded grounding connection to the tower was replaced with a 1/4-in (6.3-mm) thick copper plate (Figure 12).

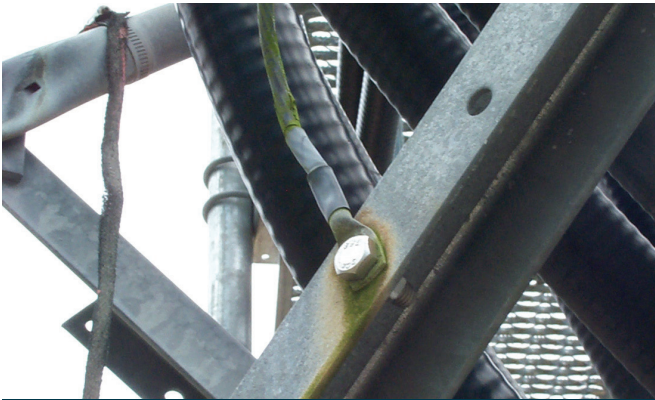
FIGURE 11.

Corrosion raised resistance at an existing cable shield ground connection on the Clarcona tower.

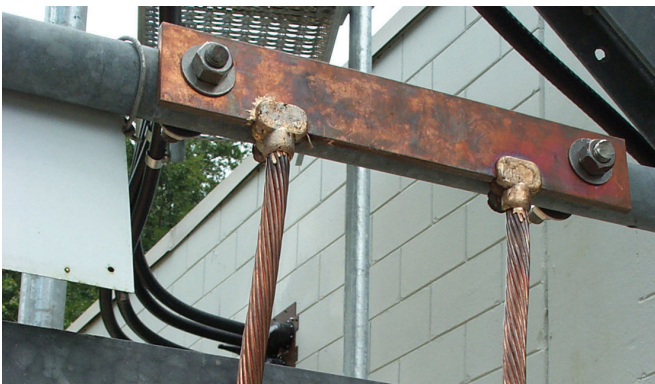
FIGURE 12.

A copper bar, large conductors and exothermic welds form secure bonds to the Clarcona tower, replacing the flimsy connection shown in Figure 11.

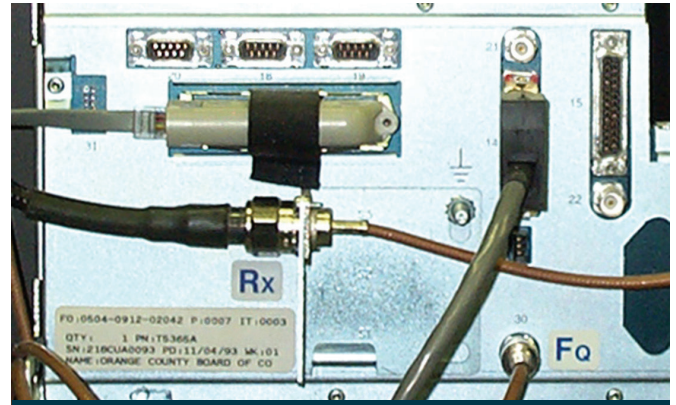
FIGURE 13.

Clearly marked grounding terminals on equipment cabinets were never connected (Figure 13). As at Apopka, the oversight left the cabinets grounded only through cable shields and the green wires in their respective power cords. The installation was not in accordance with the manufacturers' instructions, and not adequate from the standpoint of lightning protection.

A clearly marked but unused grounding terminal, evidence that equipment cabinets had not been properly grounded. Cabinet racks were grounded, but chassis were grounded only through cable shields and power cords. The practice did not provide adequate lightning protection.

Donnelly and West bonded the cabinets and racks with AWG 2 copper strung overhead to connect with copper plates on a new AWG 2/0 halo ground on the walls. The halo, which also functions as a grounding point for air conditioners and other auxiliary equipment, is bonded to the copper firewalls and to the main grounding electrode system outside the building (Figure 14).

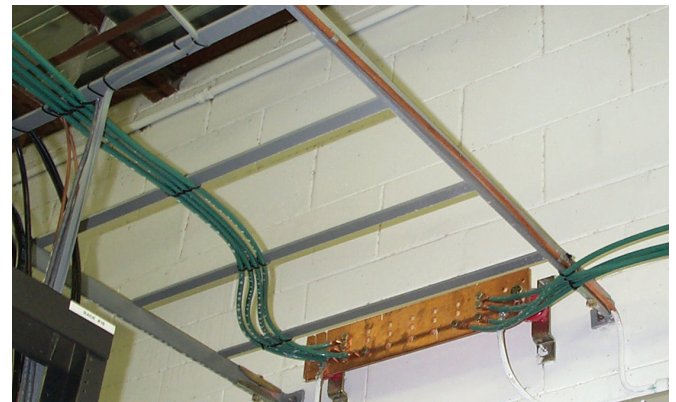
FIGURE 14.

Copper plates in a halo ground surrounding the Clarcona site communications room. The plates are bonding points for ground leads from equipment racks and cabinets and auxiliary equipment such as air conditioning units.

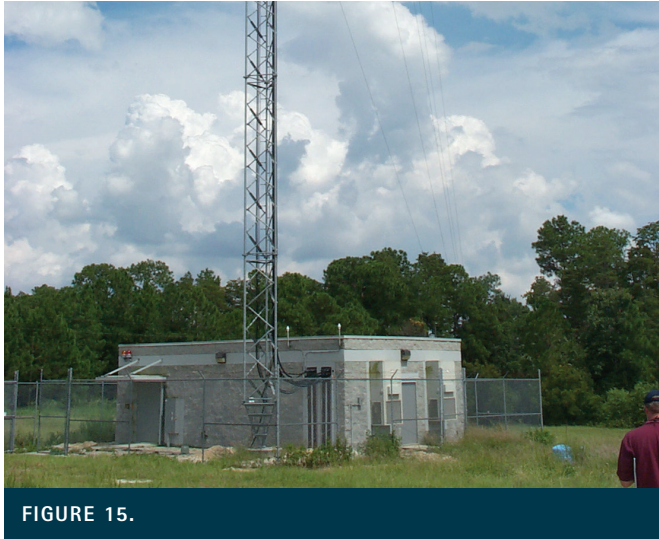
FIGURE 15.

One of the 911 system's three repeaters is located at Reedy Creek (Figure 15). The site, several miles from Orlando, is in moist terrain underlain by what Floridians call "sugar sand", a fine-grained silica that provides good drainage but has absolutely terrible conductivity.

Reedy Creek, one of Orange County's two remote repeater sites, is underlain by high-resistivity "sugar sand." Poor soil conditions, along with neglected chemical-type electrodes, raised the site's ground resistance to more than 1,000 ohms.

Chemical-type electrodes had originally been installed to enhance the soil conditions. (Salt in the electrodes leaches into the ground, raising conductivity.) As at Apopka, the electrodes had not been maintained, and at the time West inspected them, resistance was more than 1,000 ohms.

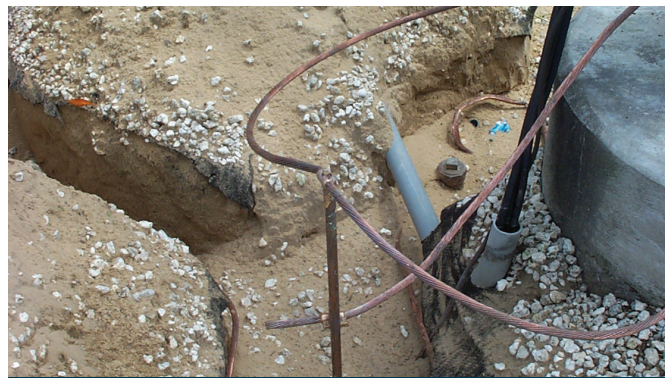
FIGURE 16A.

Figure 16a. Arrows identify new (foreground) and old (rear) grounding electrodes near the tower base (far right) at the Reedy Creek repeater, as seen during installation. Resistance of un-maintained chemical rods was higher – more than 1,000 ohms. AWG 4/0 bare copper grounding electrode conductors are bonded with exothermic welds. Figure 16b. Resistance of the new rods ranges between 3.5 and 4.4 ohms, levels that are both low enough to ground sensitive electronic equipment and suitable for reliable lightning protection.

The site was also equipped with an AWG #2 tinned copper ground ring at the base of the transmitter building. The ring was in satisfactory condition, so West and Donnelly tagged their new system to it (Figure 16a).

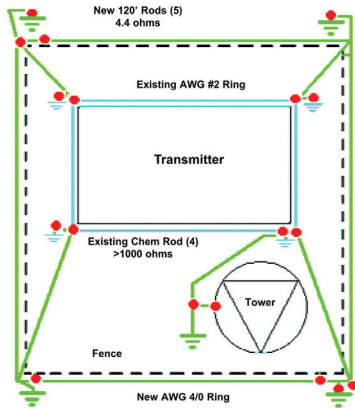
FIGURE 17.

Schematic diagram of the Reedy Creek grounding system as originally installed (blue lines) and as upgraded (green lines). Upgrades include five new 120-ft (37-m) deep, low-resistance electrodes, an AWG 4/0 ground ring at the fence line, tie-ins to the existing system and exothermic welds throughout.
